# Making matters worse with Impella

## Rizar el rizo en el soporte con Impella

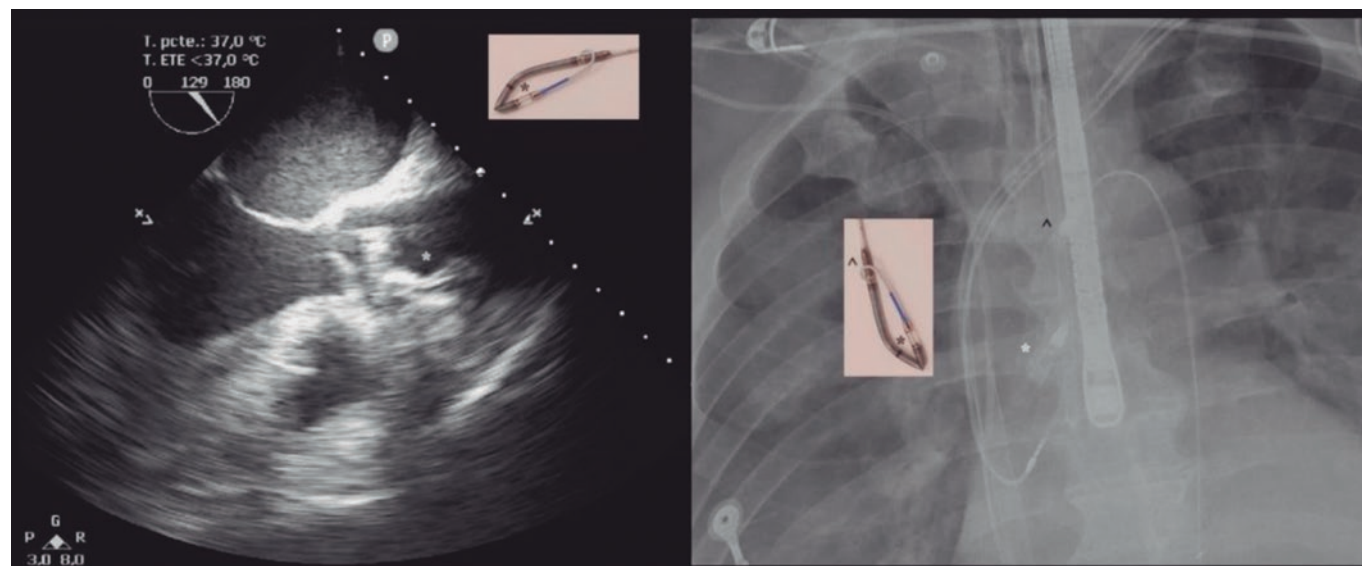
Figure 1.

A 53-year-old man was treated with extracorporeal cardiopulmonary resuscitation with the controlled automated reperfusion of the whole body (CARL) system (Resuscitec, Germany) after a refractory in-hospital cardiac arrest following an arrhythmic storm in the setting of an episode of inflammatory cardiomyopathy. The patient required Impella-CP device implantation (Abiomed, United States) via femoral access due to insufficient unloading with the intra-aortic balloon pump. Catheter malapposition was suspected after several suction alarms were triggered. Despite repeated attempts at repositioning, flow rates remained  $< 1$  L/min. Transesophageal echocardiography and thoracic x-ray (figure 1) confirmed that the catheter had bent in upon itself (asterisk in the figure), and the pigtail had been caught in the outlet (figure 2) following the multiple attempts at repositioning. The catheter migrated toward the descending aorta and urgent removal was decided. An attempt to unscrew the pigtail through femoral manipulation proved unsuccessful (figure 3A and video 1 of the supplementary data). A 7-Fr Amplatz Super-Stiff guidewire (Boston Scientific, United States) was advanced through the Impella loop via left radial access, and traction on the catheter from the femoral access successfully disengaged the pigtail from the outlet (figure 3B). Concurrently, a 12 mm  $\times$  20 mm EN-Snare loop (Merit Medical, United States) was inserted to capture the tip of the pigtail (figure 3C). The guidewire was removed and traction was applied simultaneously to the Impella device and the pigtail tip, which extended the Impella (figure 3D and video 2 of the supplementary data) and allowed its extraction through its introducer. We decided not to restart the device due to the risk of thrombosis in its interior, and chose to remove it using a 14-Fr transaortic pigtail catheter through the Impella access.
