PICTURES IN DIGESTIVE PATHOLOGY

Anal incontinence: evaluation of the anal sphincter by endoscopic ultrasound

Unit of Diagnosis and Ecographic and Endoscopic Treatment. Clínica Nuestra Señora de la Salud. Cádiz, Spain

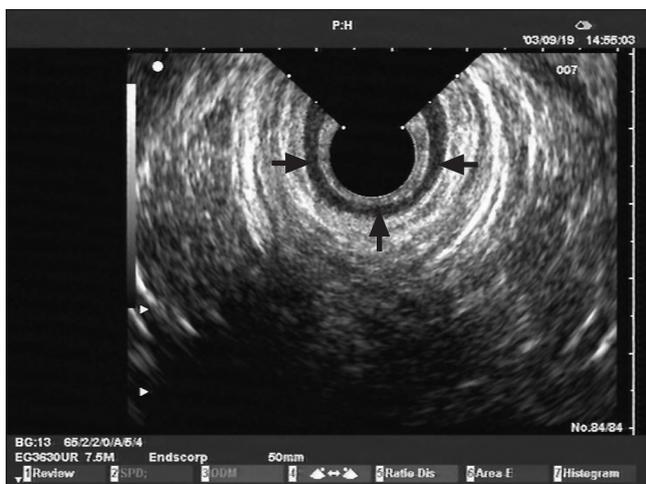
Fig. 1.- Normal internal anal sphincter (showed by a radial-scanning echoendoscope at a frequency of 7.5 MHz). Hypoechoic band marked by arrows.

Esfínter anal interno indemne (visualizado con sonda endosonográfica radial a una frecuencia de 7,5 MHz): banda hipocogénica delimitada por las flechas.

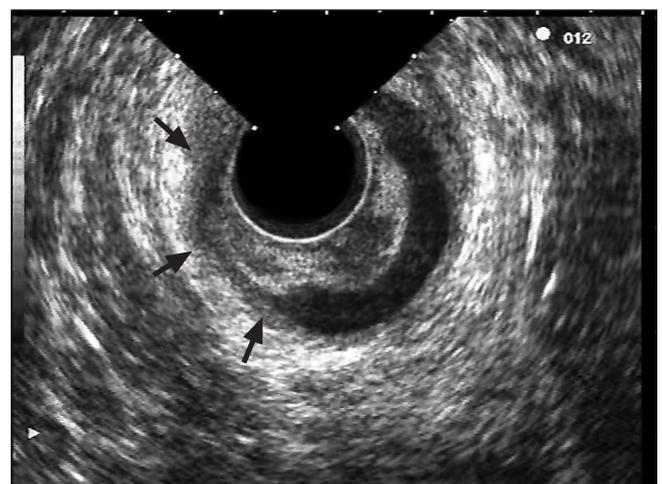
Fig. 2.- Internal anal sphincter defect (showed by a radial-scanning echoendoscope at a frequency of 7.5 MHz): the hypoechoic band is clearly interrupted in half of the circumference (arrows).

Defecto del esfínter anal interno (visualizado con sonda endosonográfica radial a una frecuencia de 7,5 MHz): la banda hipocogénica se ve claramente interrumpida en la mitad de la circunferencia (flechas).

We performed an anal inspection and a digital rectal examination. There were no anatomical defects, but a severe hypotonic anal sphincter was encountered. Since there is a radial-scanning ultrasound endoscope with frontal vision (Pentax EG3630UR) available in our Unit, an endoscopic review of the rectal and sigmoid mucosa was carried out, with no abnormalities being detected. A radial endoscopic ultrasonography was performed using a frequency of 7.5 MHz during the same exploration. At the middle of the anal canal, the internal anal sphincter is seen as a hypoechoic ring under normal conditions (Fig. 1). In this patient there was a 50% defect at this hypoechoic band representing the internal anal sphincter (Fig. 2). No defects in the external anal sphincter were seen, other than it was slightly thin. The patient had fecal incontinence due to proctologic surgery with internal and sphincter damage. Therefore, the patient had fecal incontinence due to her proctologic surgery having damaged the internal anal sphincter. An anorectal manometry was performed, and it confirmed the internal anal sphincter hypotonia and also showed a lower pressure at the external anal sphincter.
