IMAGES IN UROLOGY

Arch. Esp. Urol. 2009; 62 (6): 510-511

"AN INFREQUENT COMPLICATION OF A PENILE PROSTHESIS"

Department of Urology. Hospital Juan Canalejo. La Coruña. Spain.

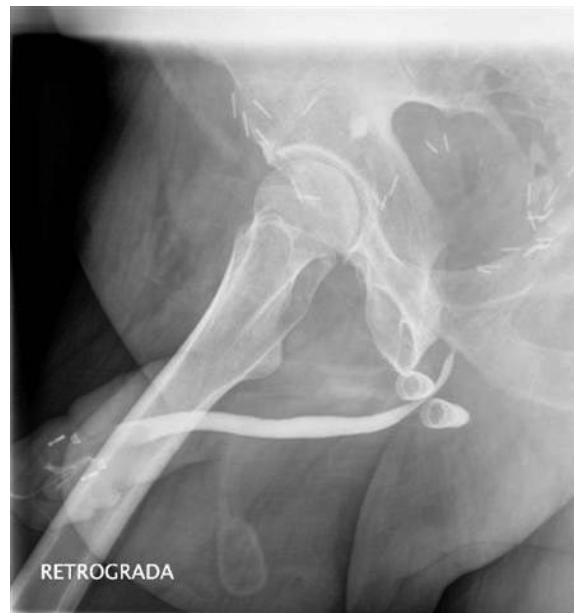
FIGURE 1. Retrograde urethrography: a normal bulbar urethra

The cystourethrography shows a fistula communicating the uretra and the right corpus cavernosum (FIGURES 1, 2 and 3), in order to which a surgical removing of the prosthetic material is performed and the corpus cavernosum is sutured.

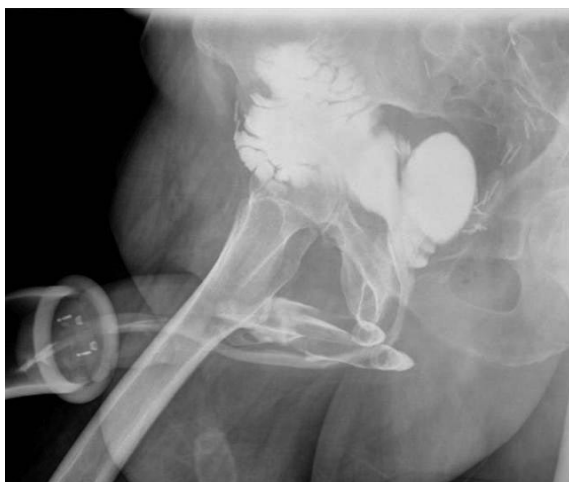
FIGURE 3. Voiding image: a contrast leakage is still showed. leo-colic orthotopic neobladder.
